Manhole Inspection Summary

Manhole # S270__003MH

Insp Date: **4/30/08 1:13 PM**

Location Address: **Dexter St**

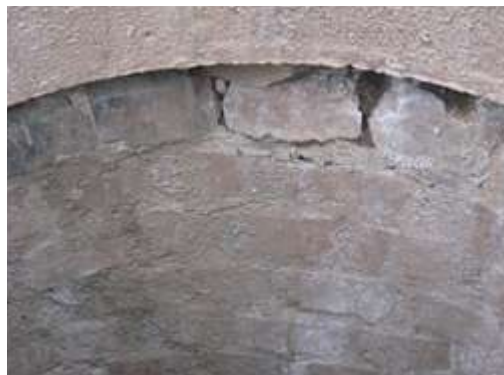
Defect 2

Frame Offset: **1** (in.) Condition: ☐ Sound ☐ Cracked ☒ **Leaks**

Condition: ☐ Sound ☒ **Cracked** ☐ Root Intrusion ☒ **Loose Brick** ☐ Deteriorated

Infiltration: ☐ None ☐ Joint ☐ Cracks ☒ **Mortar** ☐ Roots ☒ **Wall**

frame leaks, Missing mortar, cracked chimney and Loose bricks - source of infiltraion

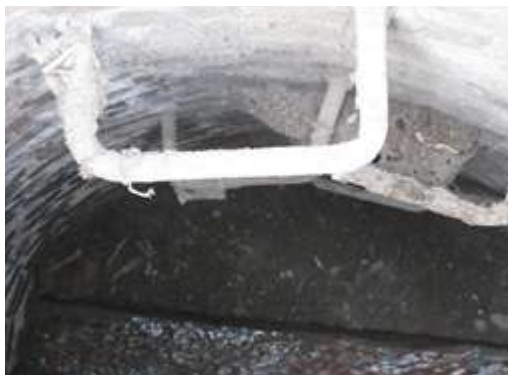
Defect 1

Steps Count: **4** Missing: **0** ☒ **Corroded**

debri on bench/corroded steps

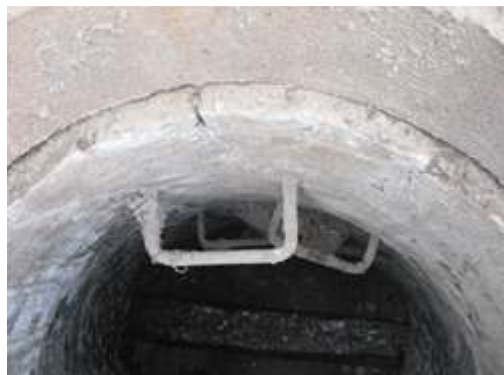
Defect 3

1" offset
